# Property Condition Assessment & Facility Condition Index Analysis

**Aylmer Police Office  
20 Beech Street East,  
Aylmer, Ontario**

Prepared for:  
Town of Aylmer  
46 Talbot Street West,  
Aylmer, Ontario  
N5H 1J7

November 17, 2022  
IRC LB22-066CR-25445

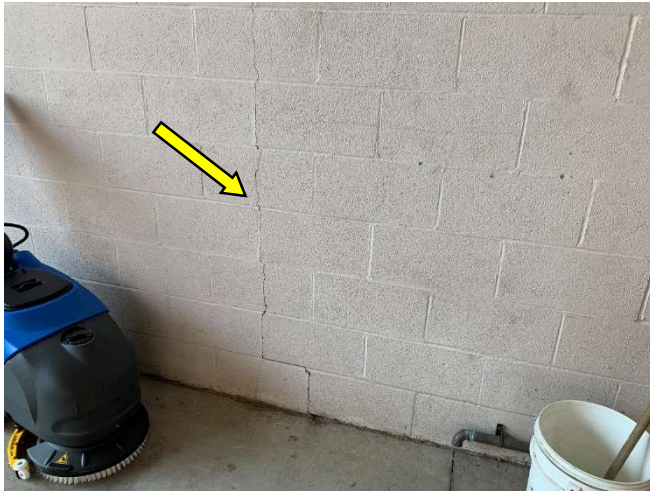
Cracking was observed at an exposed section of concrete masonry unit walls in the attached garage.

- IRC has carried an allowance to repair the damaged sections of concrete masonry within the term of analysis. Budgetary costs include for general masonry repairs such as repointing of failed mortar joints, rebuild of cracked or spalled areas, foundation parging repairs etc. The cost does not account for major structural repair or reconstruction of the concrete block masonry as a whole.

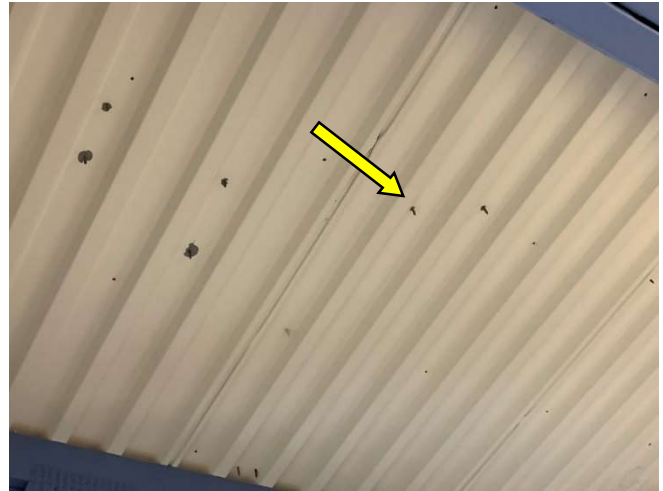
IRC observed shingle roofing nails through the exposed sections of the underside of the metal roof decking.

- Once the roof coverings are removed during upcoming replacements, IRC anticipates finding damaged sections within the decking and sheathing that will require isolated repairs. A budgetary allowance has been carried for minor repairs of roof structural components in conjunction with roof systems replacements within the term of analysis. This allowance is to cover the cost of decking repairs and has been carried in conjunction with roofing membrane and asphalt shingle replacement.

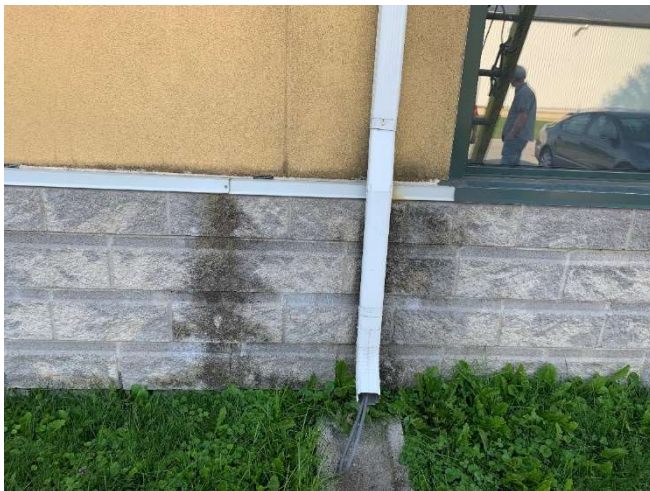
The split faced concrete block masonry was noted to be stained with moisture at a few locations.

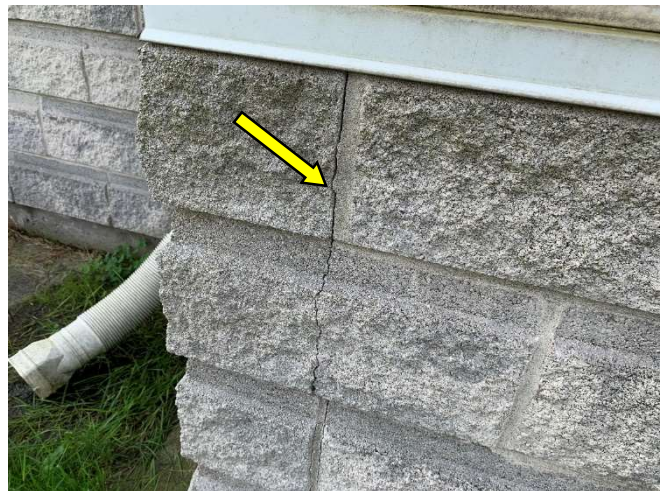
Minor cracking was observed in the split faced concrete block along the north elevation.

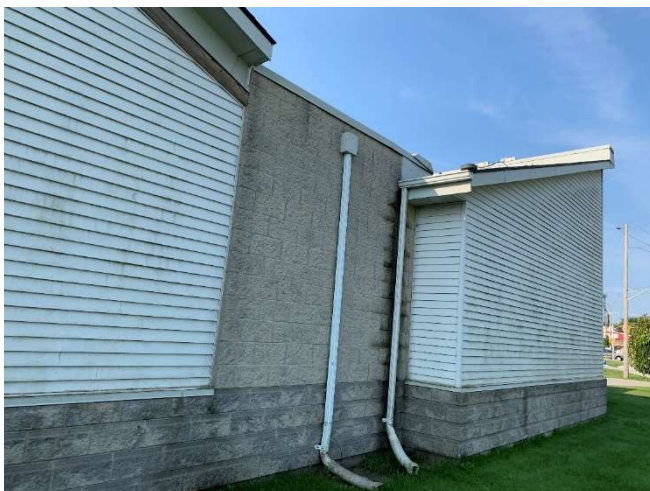
Staining was observed on the refinished aluminum siding. Consideration should be given to cleaning the siding.

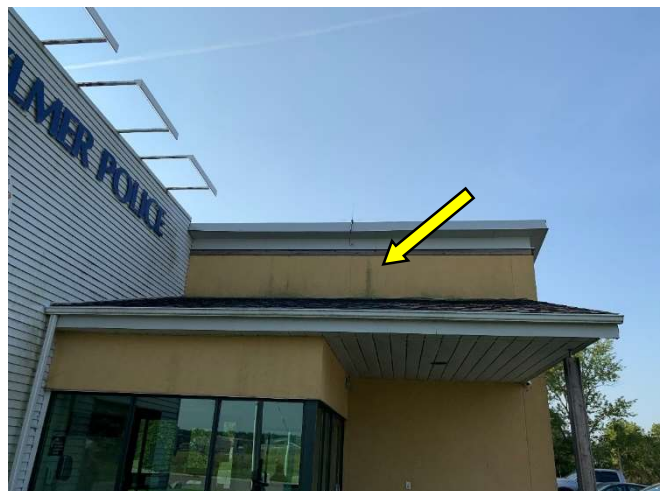
Severe staining was observed on the EIFS above the roof overhang at the main entrance.

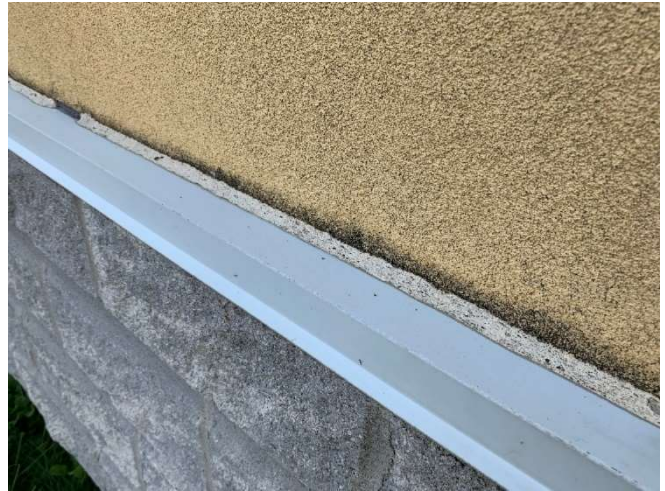
The caulking at the EIFS transition to the split faced concrete block was observed to be in poor condition.

- IRC has carried an allowance to cover the costs of future sealant replacement cycles within the next 0 to 2 years.
- It is typically not expected that all fire safety components would need to be replaced on a cyclical basis, rather as and when needed. IRC has carried an allowance for upgrades to the fire protection systems within the next 0 to 2 years.

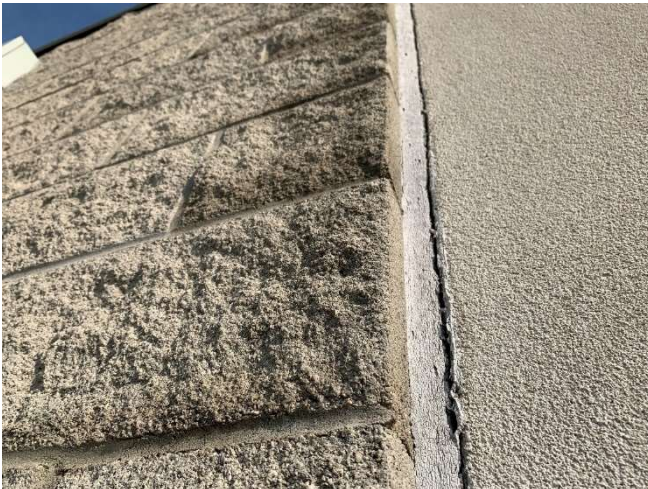
View of the failed sealant observed at an exterior wall transition located along the south elevation.

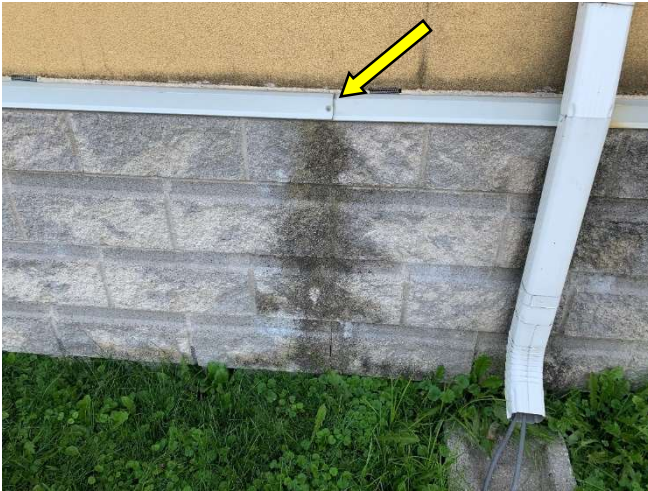
A leaky joint at the wall drip-edge is causing moisture staining/damage on the exterior masonry.

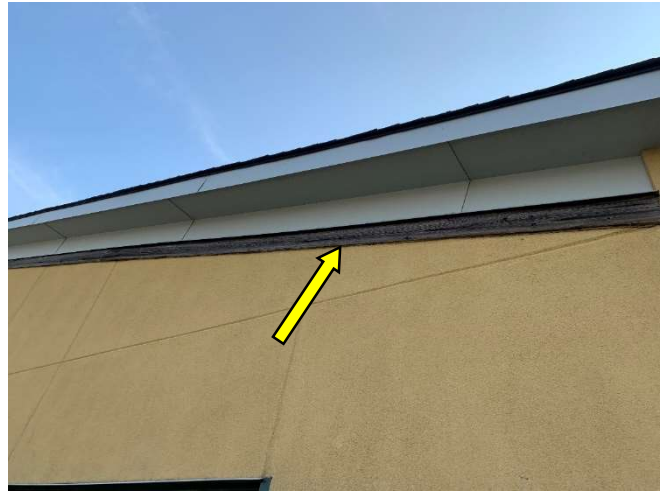
- Wood trim was observed on the exterior walls below the aluminum roof flashings. The wood trim has surpassed the service life and replacement with metal flashing is recommended.

The wood trim has surpassed the serviceable life and replacement with metal flashing is recommended.

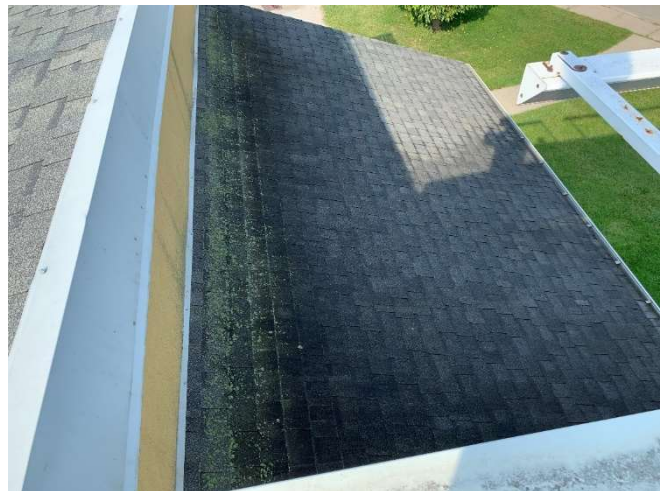
Saturated shingles with moss growth were observed on the asphalt shingles on the main entrance roof overhang.

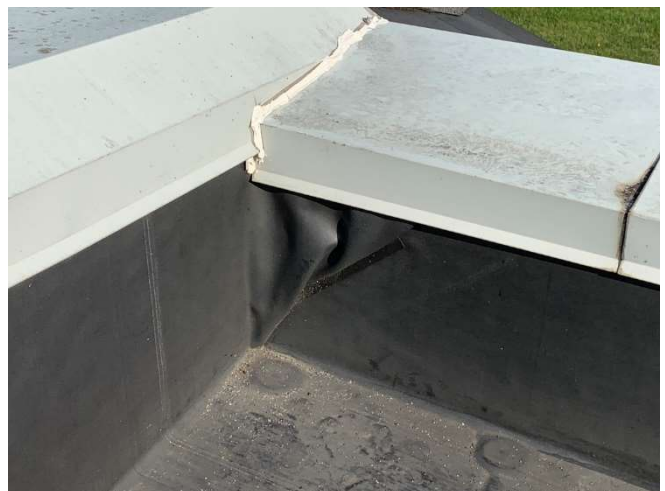
Evidence of poor installation in the form of wrinkling was observed in the EPDM roofing system.

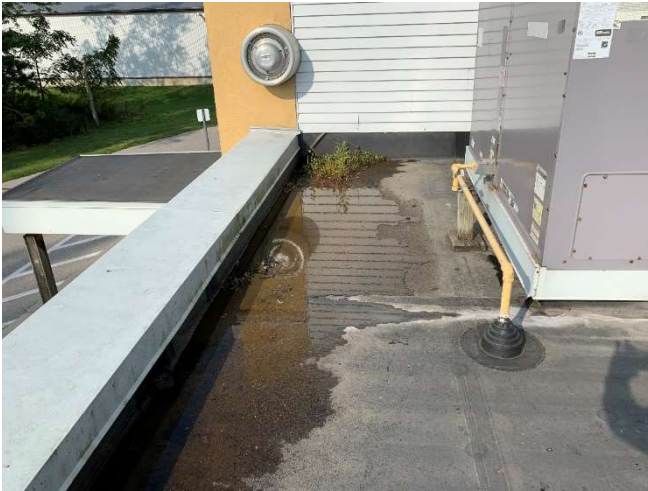
Water ponding and vegetation growth was observed at the south end of the building.

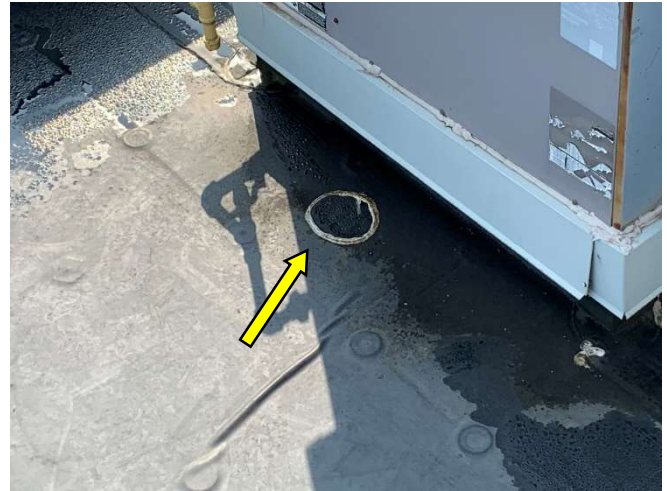
Patch repairs have been completed in previous years at the location of the ongoing leak above the cell block area.

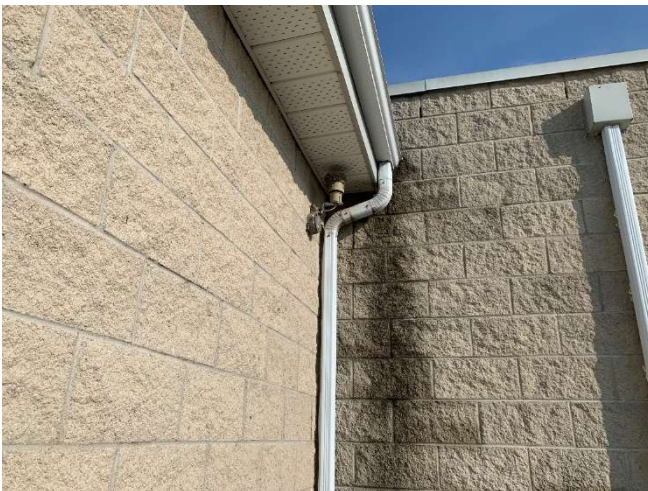
A section of eavestrough along the east elevation was observed to be discharging onto the concrete block wall.

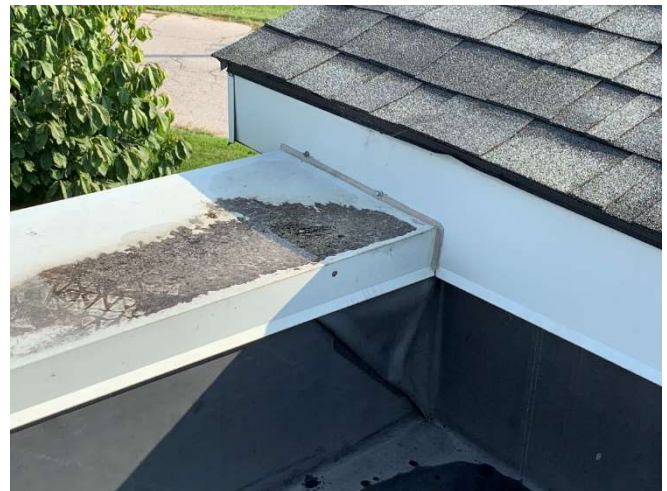
Moisture staining/debris accumulation were observed at the roof parapet flashings.

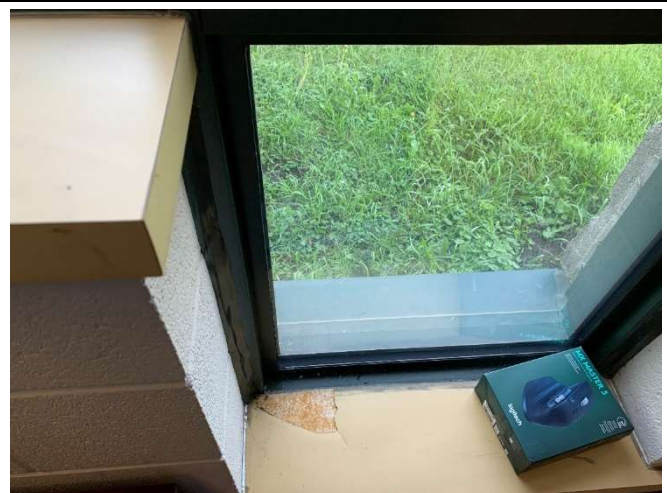
Water damage was observed at the windowsill in the fingerprint room.

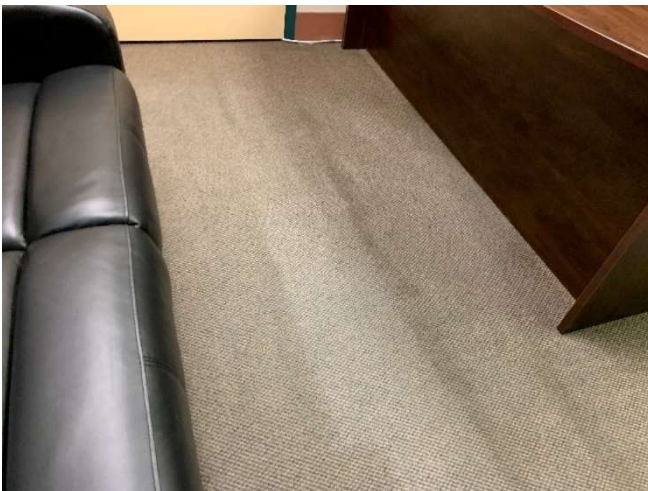
Rips and wrinkled carpet observed in the meeting room.

- An allowance has been carried for repairs to the interior wall finishes.
- Budgetary cost expenditure has been allocated for replacement of some of the flooring. The allowance is carried keeping in mind the like-with-like criteria, actual cost will depend on the type of flooring chosen, which will be determined based on the intended use of the building.

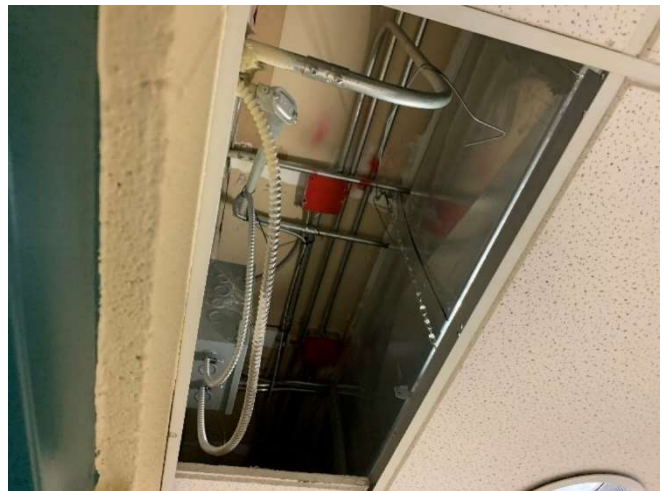
Missing ceiling tiles observed in the women's locker room.

- Budgetary cost expenditure has been allocated for replacement of some of the ceiling finishes.
- It is typically not expected that all plumbing fixtures would need to be replaced on a cyclical basis, rather as and when needed. Budgetary cost expenditure has been allocated for replacement of some of the plumbing fixtures.

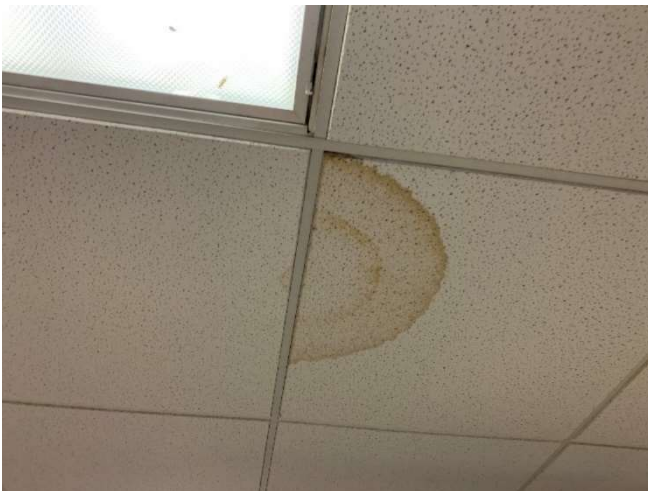
Stained ceiling tile observed in the fingerprint room.

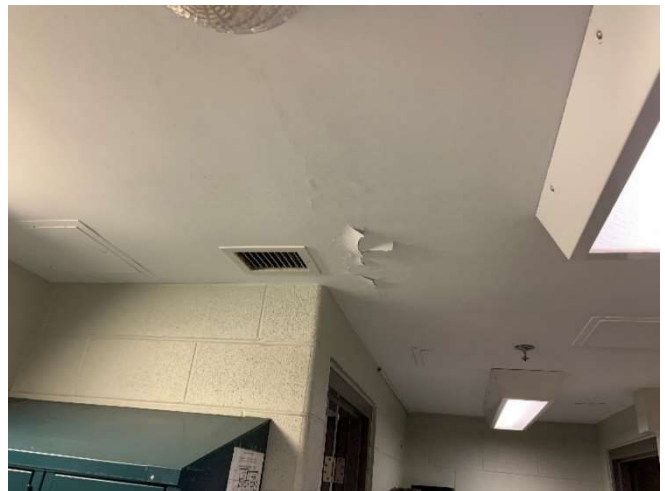
Damaged ceiling finishes observed above the holding cell area.

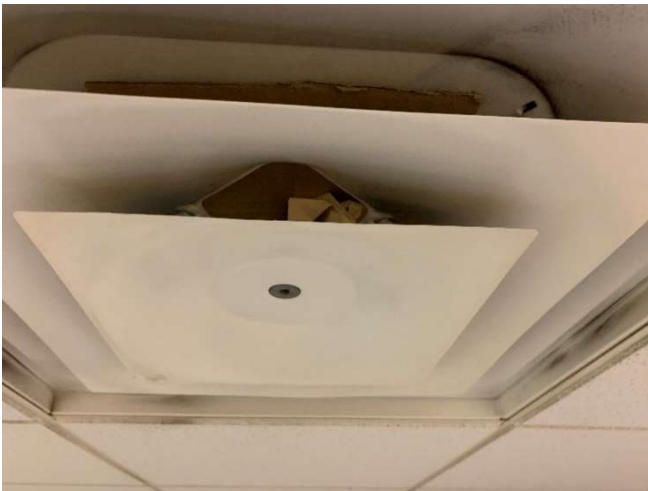
IRC observed that newspaper has been placed in the duct openings in some of the offices.

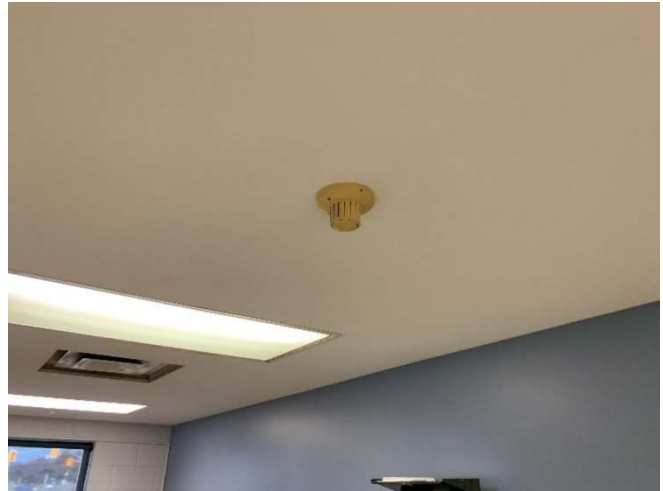
Heat sensors were observed at some locations but have surpassed the recommended serviceable life.

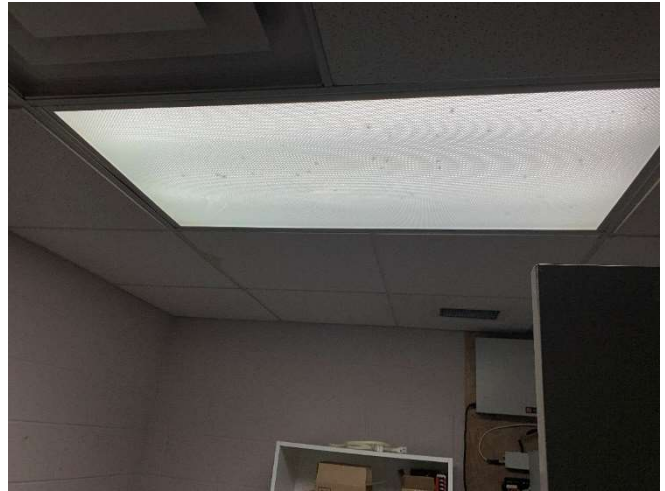
Water staining and possible damages were observed at the light fixture in the breath test room.

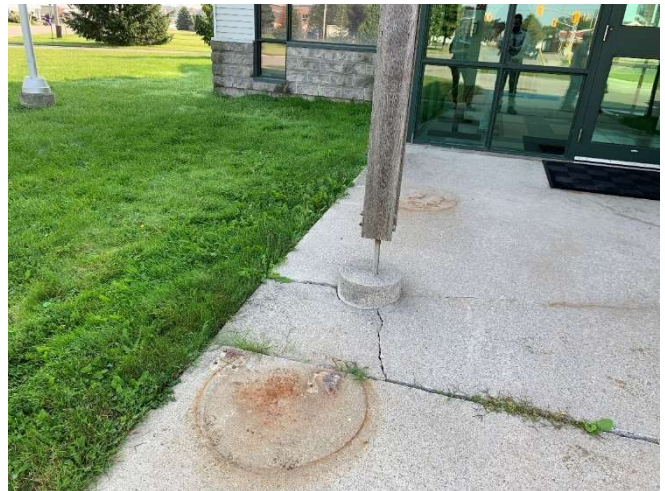
Settlement observed in the concrete pad surrounding the concrete pier at the main entrance.

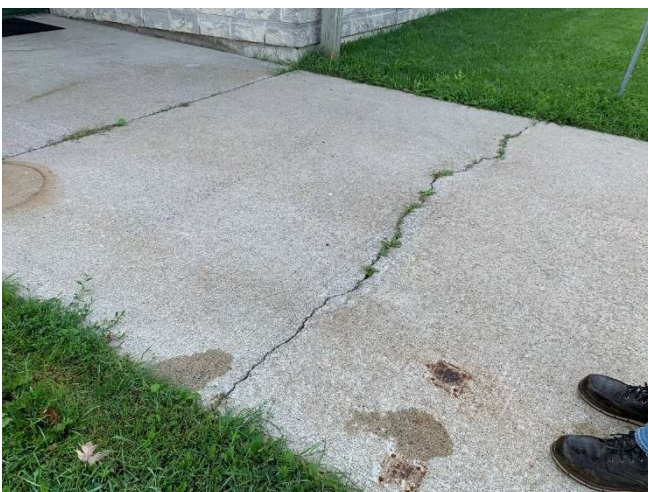
Cracking in the concrete walkways was noted at various locations around the site.

- An allowance of 25% of the total concrete costs have been carried in 2026 and every 15 years thereafter, based upon the degree of concrete damage noted during the site review.

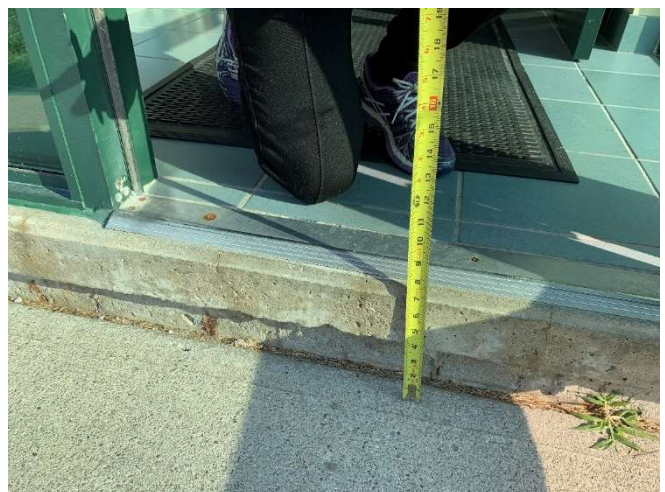
The concrete pad at the secondary entrance is not flush with the entrance door threshold.

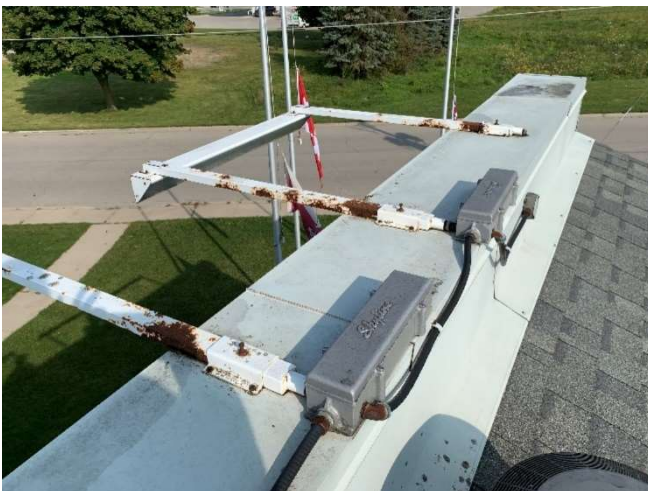
Corrosion was observed on the exterior light fixture brackets along the roof line at the west elevation entrance.

- An allowance has been carried for regular upgrades to the landscaping every 5 years.
- IRC has carried an allowance for the replacement of the exterior and site lighting within the next 2 to 5 years.
