Property Condition Assessment & Capital Planning

East Elgin Community Complex 531 Talbot St. W., Aylmer, Ontario

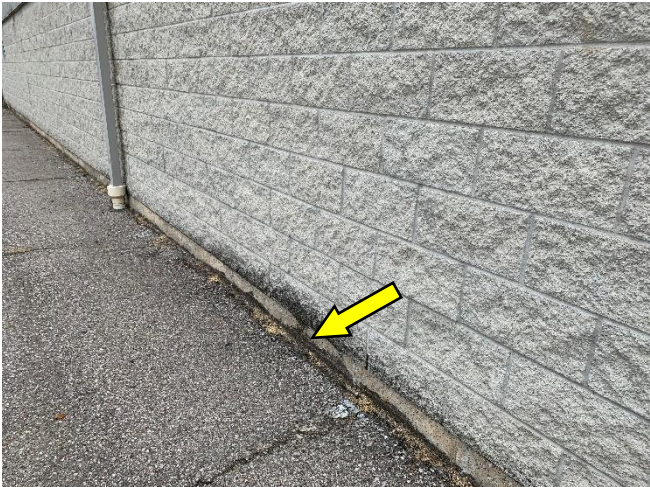
<p>Moisture damage due to negative sloping on the exterior edge of the slab-on-grade.</p>

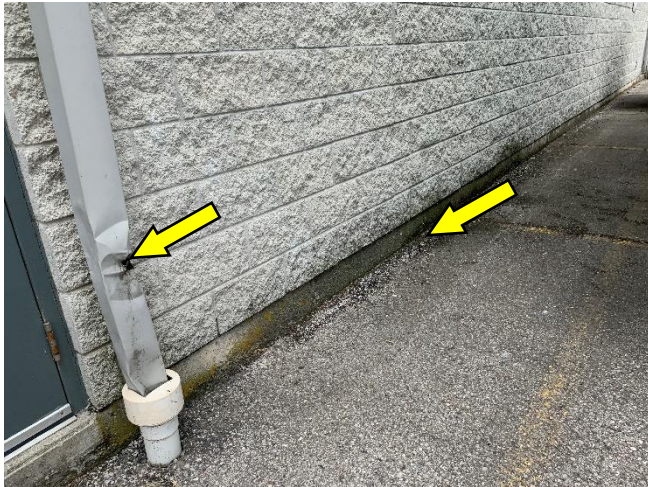
<p>A damaged downpipe and moisture stained exterior edge of the slab-on-grade.</p>

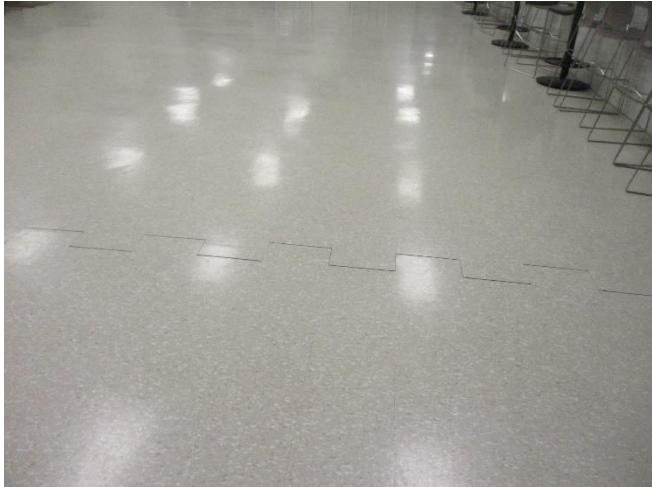
Gapping floor tiles on the mezzanine indicates movement of the subfloor.

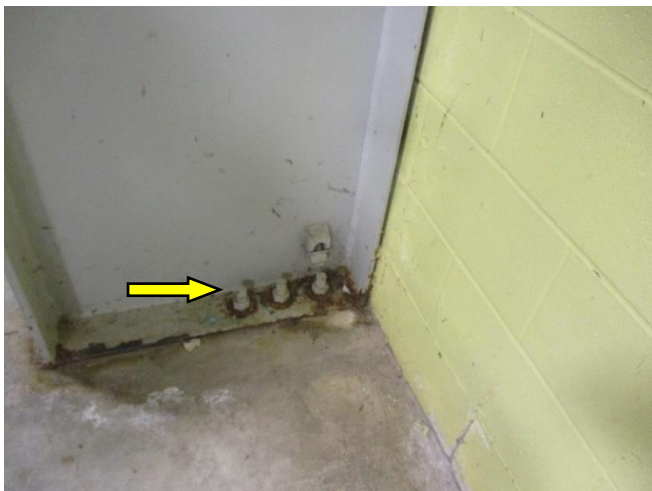
Corrosion noted on the columns.

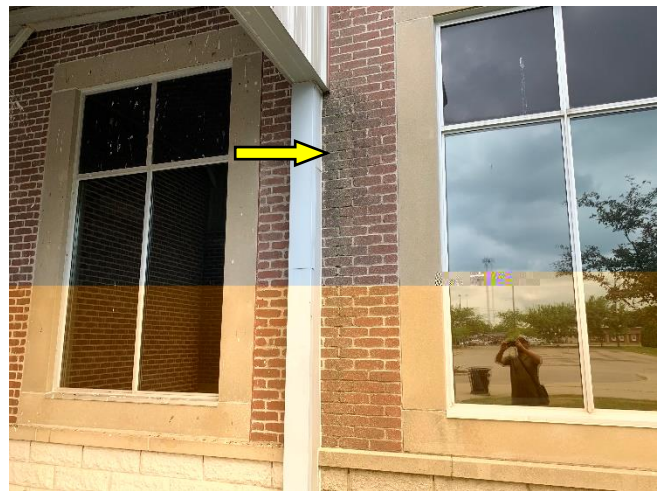
View of moisture damaged brick masonry on the south elevation.

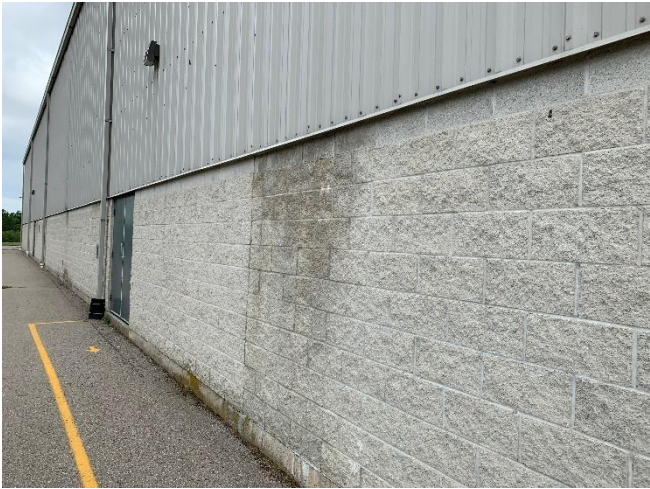
Moisture damage noted on the split-faced concrete block walls.

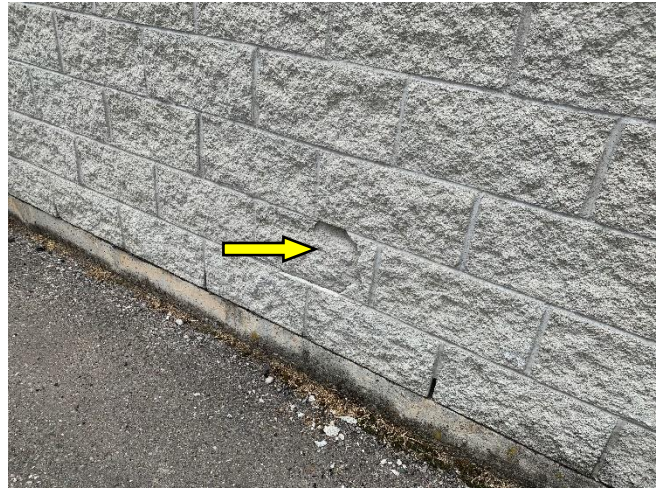
Impact damage noted on the west elevation. .

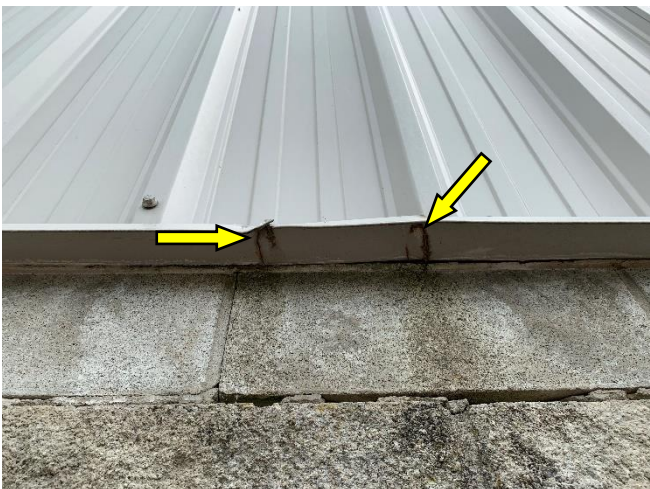
Damaged drip edge at the base of the siding causing water run-off on the masonry.

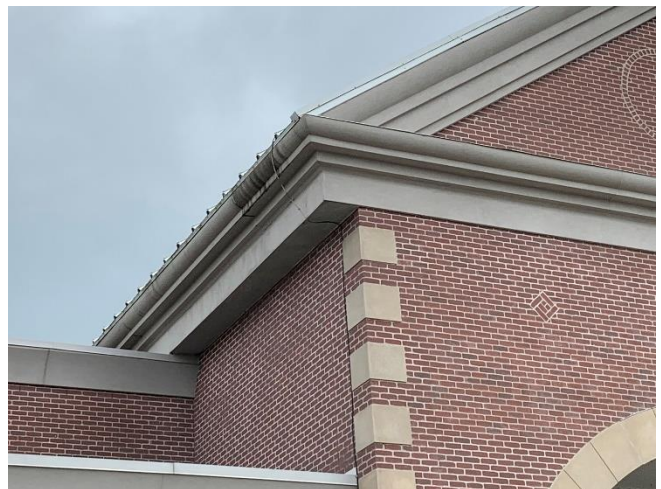
Deteriorated EIFS moulding on the southwest.

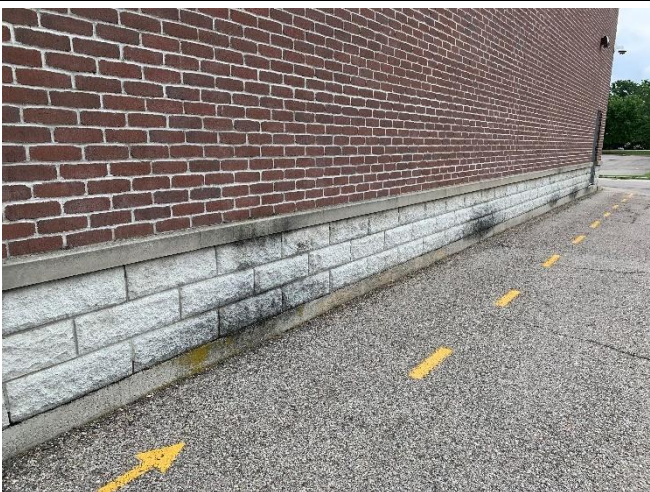
Moisture noted damage on concrete ledge and blocks.

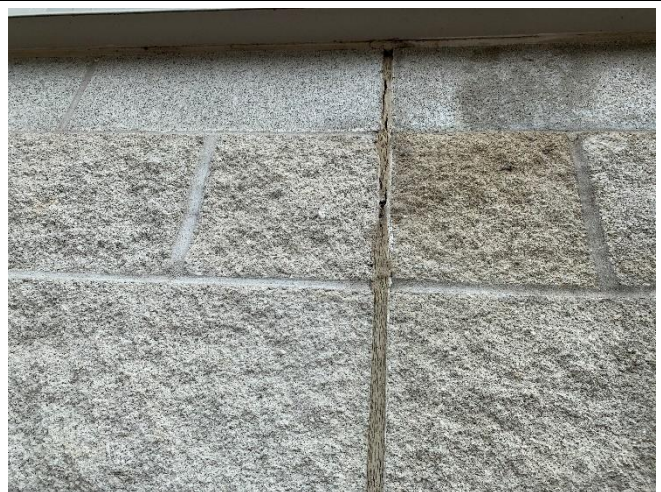
Deteriorated sealant at a control joint.

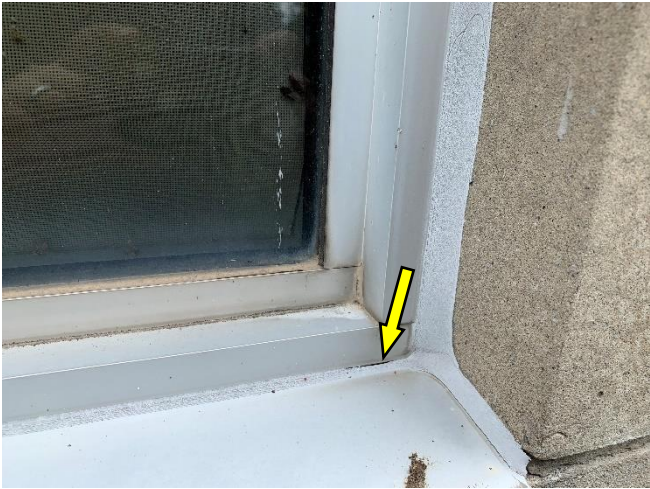
Failing and hardened sealants at a window perimeter.

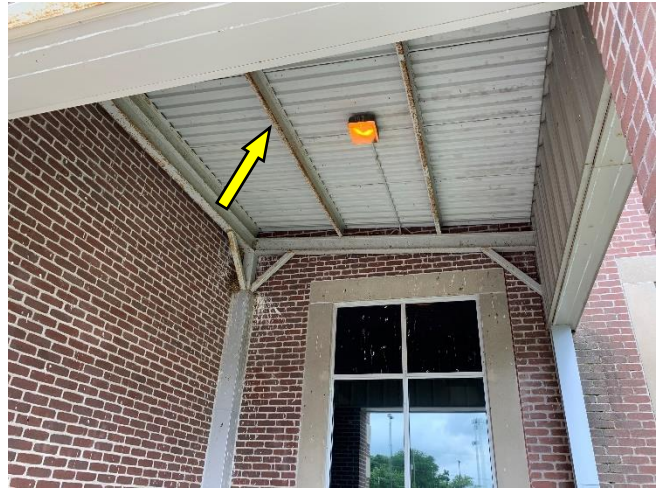
Corroding metal at an exterior soffit.

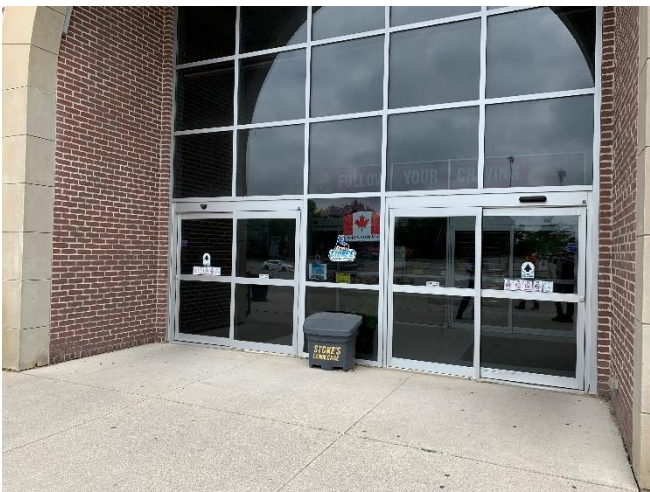
Exterior view of the main entrance glazing.

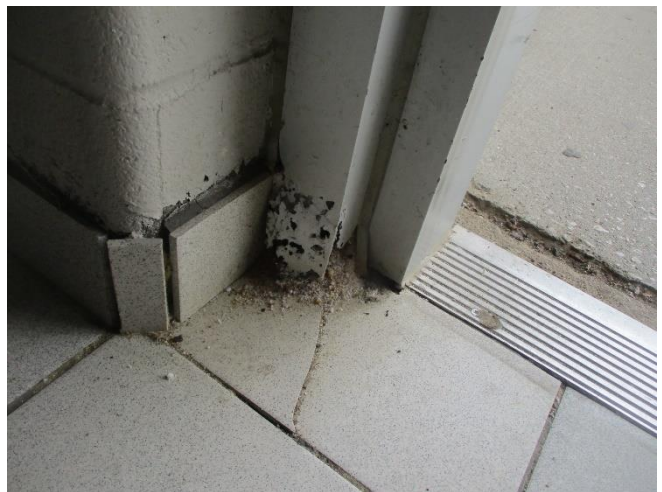
Damaged frame of the main entrance door.

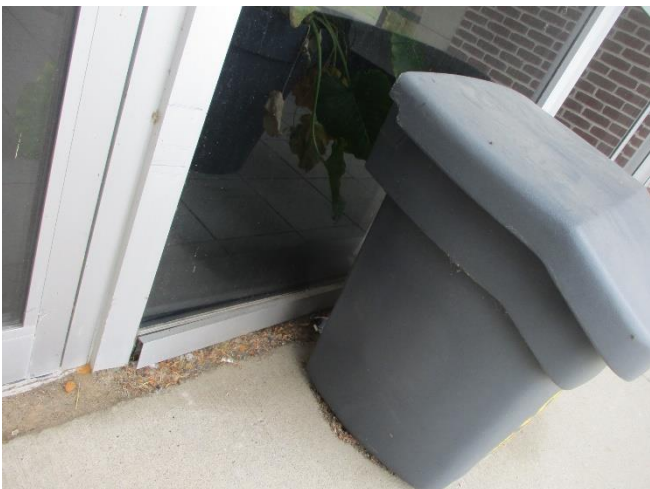
Damaged exterior face of the main door framing.

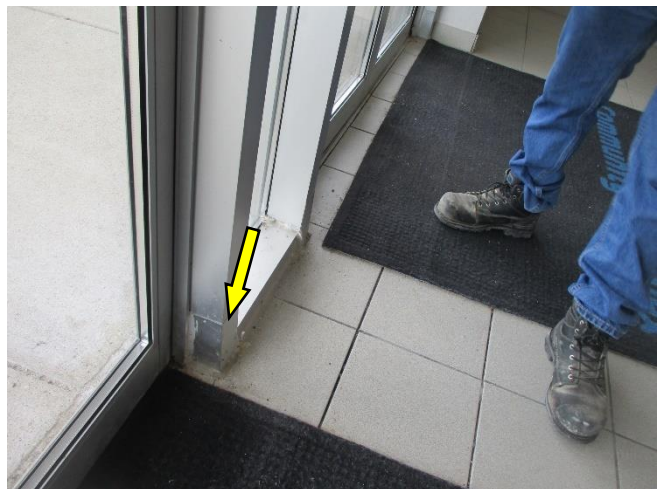
Previously patched main entrance door frame.

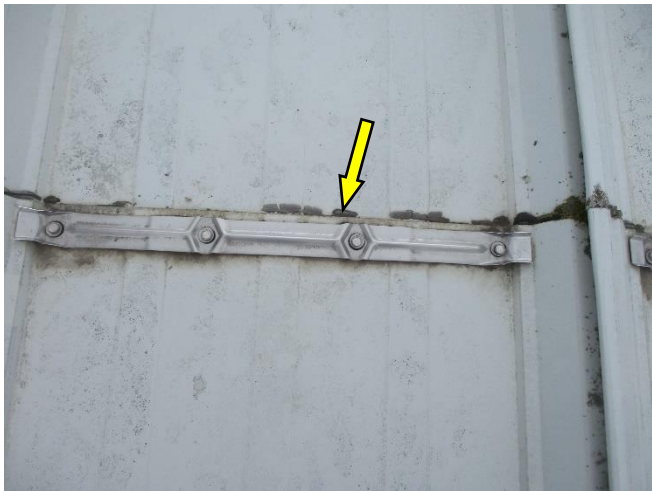
Roof A: Deteriorated sealants at joints.

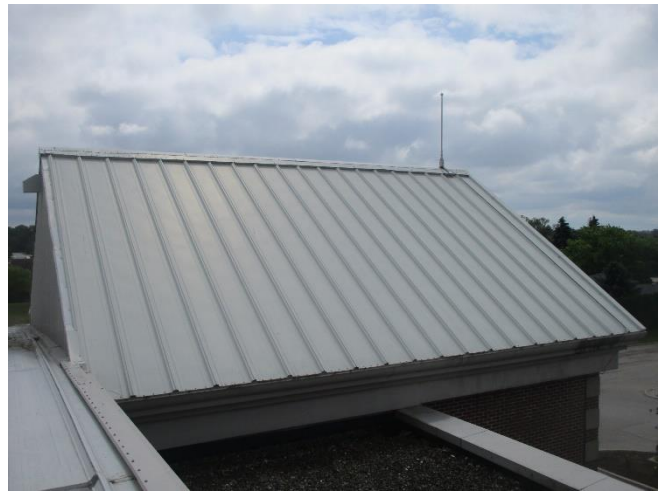
Roof B: General view of the prefinished metal roof.

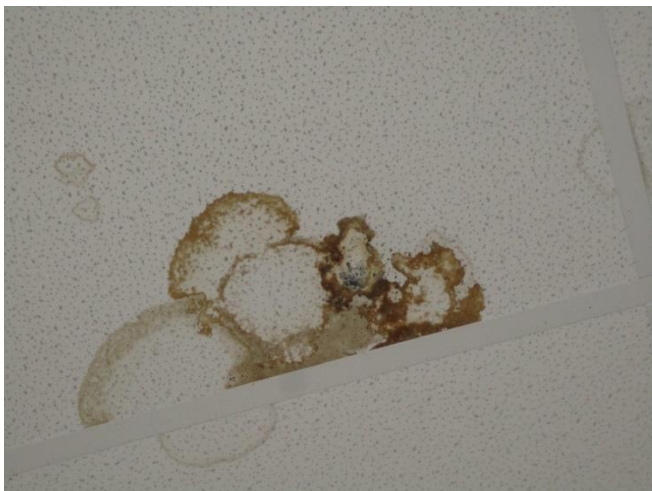
Evidenc of roof leak beneath C1.1

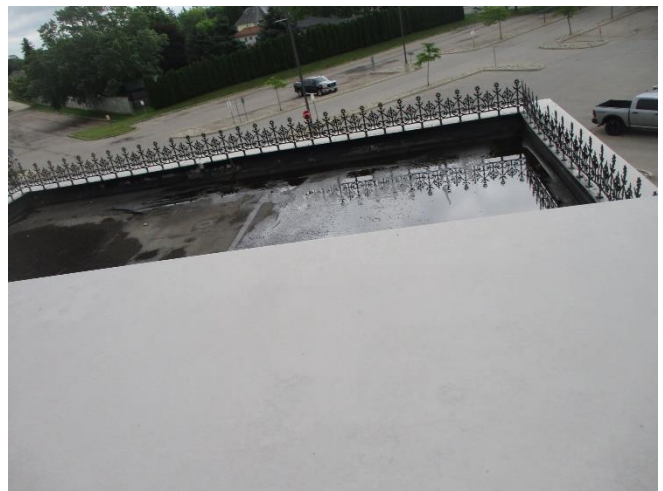
Roof D: Ponding water noted atop the roof.

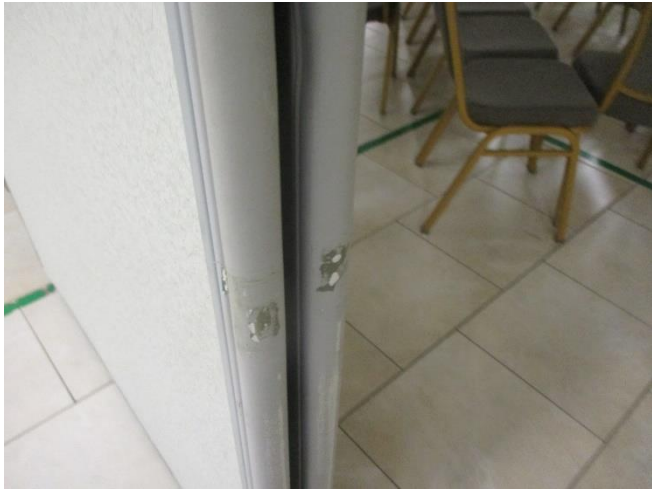
Retractable/folding partition wall at the community hall. .

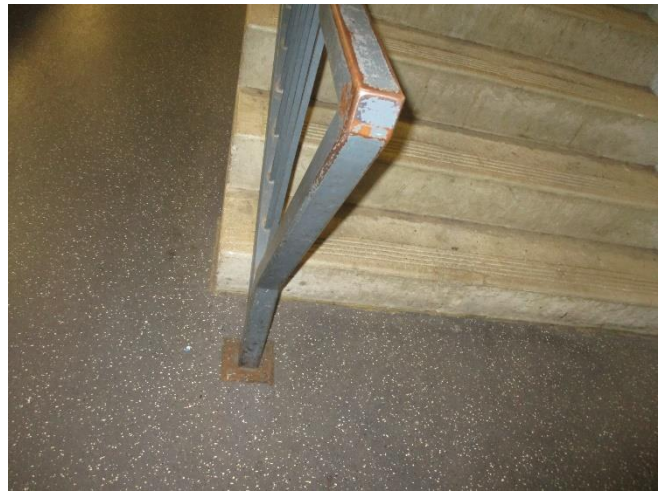
Corroding/fading guardrails at the stairs.

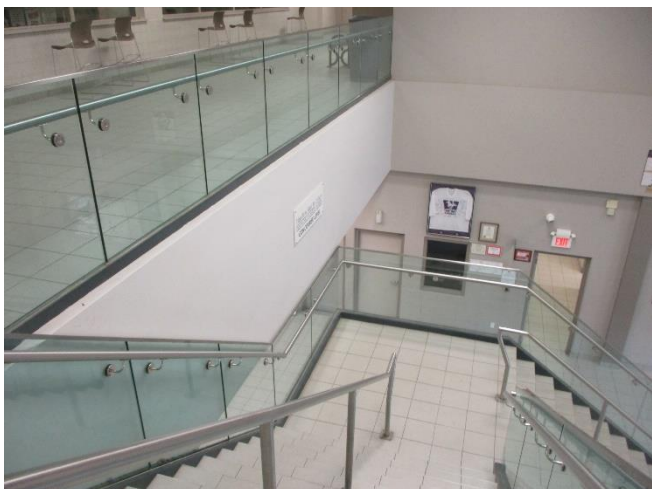
Stairs from the mezzanine to the main lobby were noted in good condition.

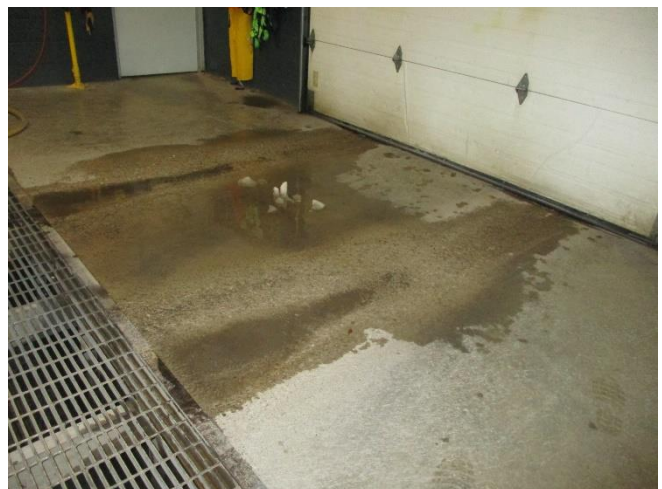
Deteriorated concrete at ice re-surfer room.

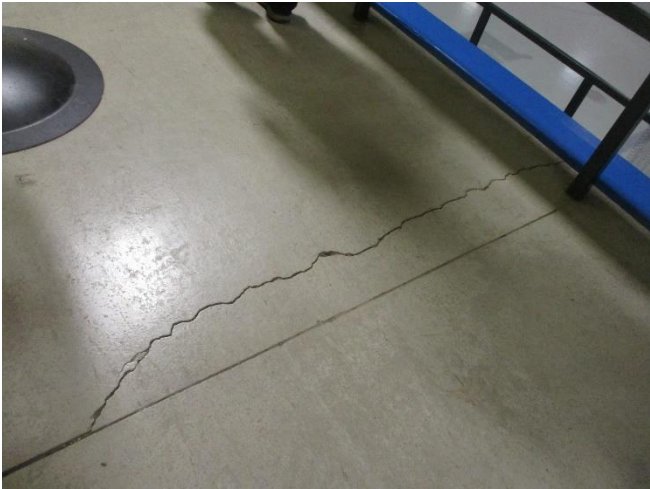
Cracked concrete topping at the seating area.

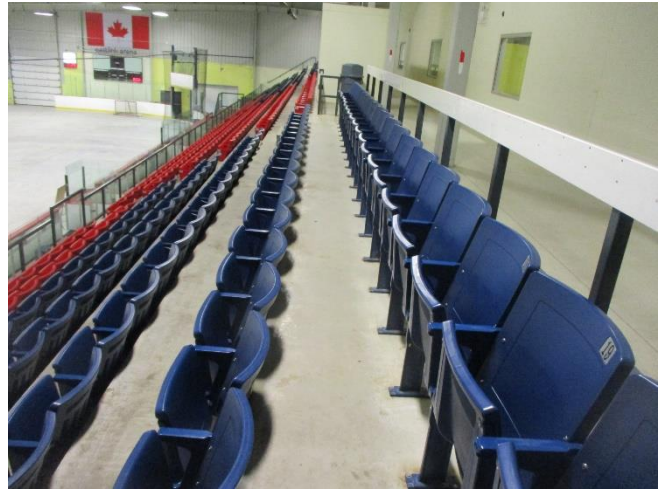
General view of the seating area at the arena.

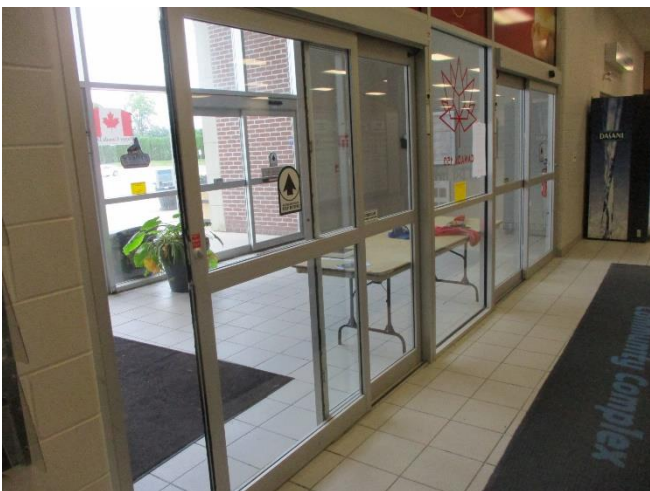
Flooring at the main entrance was in fair condition.

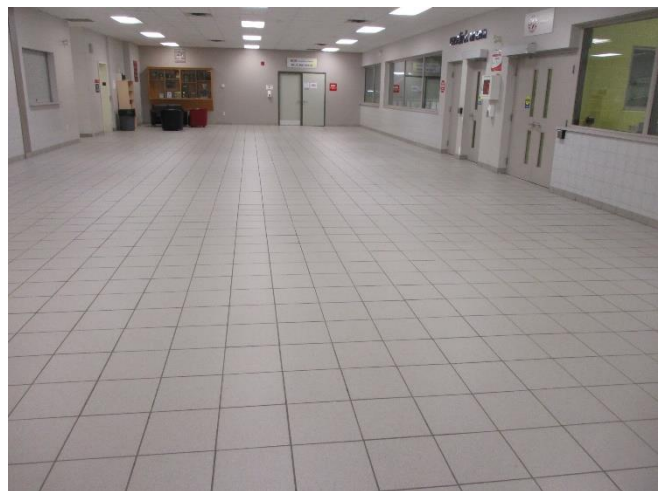
Flooring at the main level.

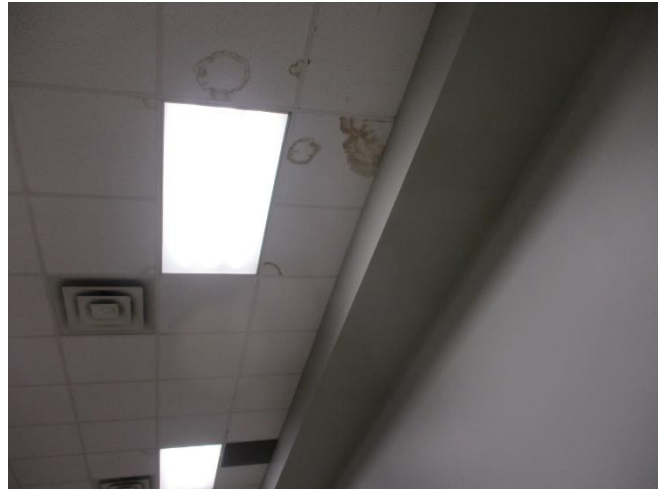
Stained ceiling tiles at the community hall.

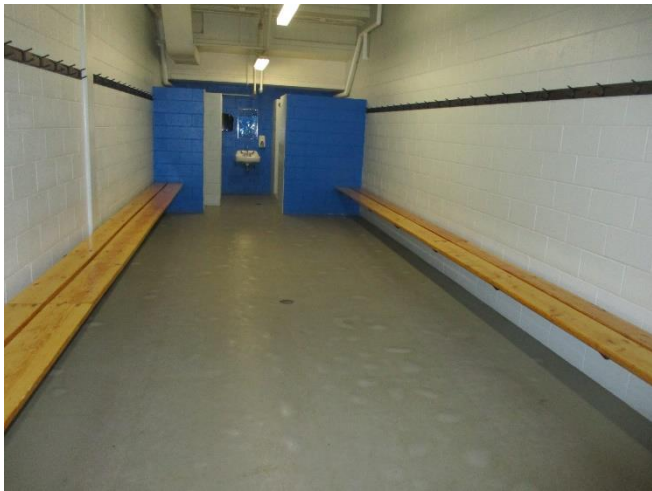
Deteriorated flooring at a change room.

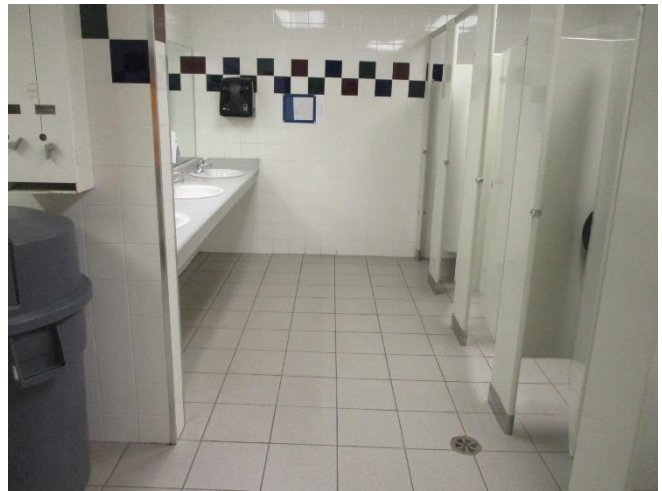
Finishes within a typical public washroom.

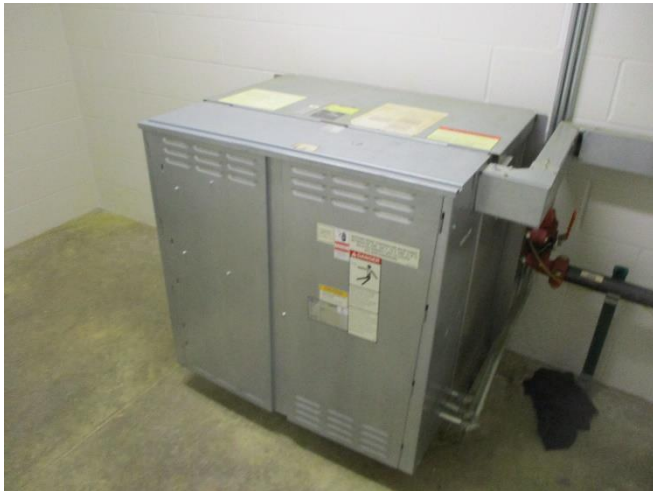
General view of the elevator machine serving the Building.

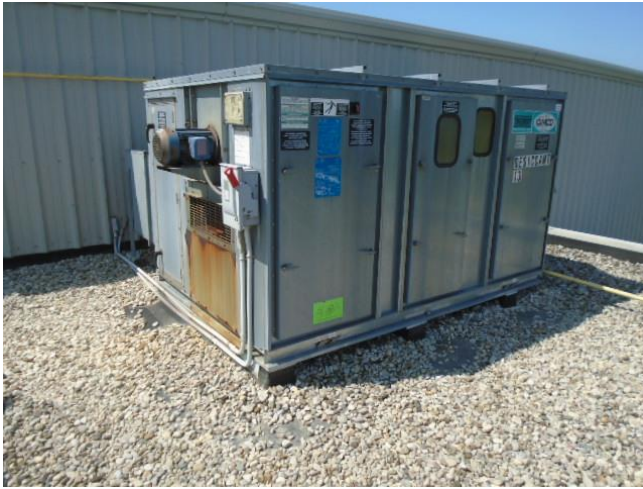
De-humidification unit.

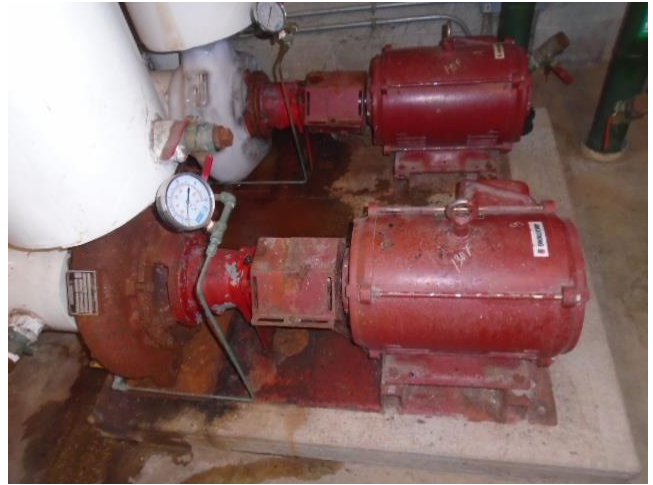
Glycol cooling pumps.

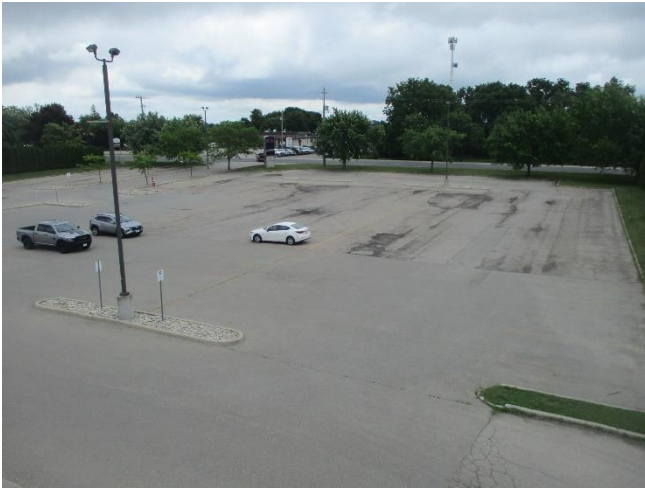
View of asphalt pavement on the south central portion of the Site.

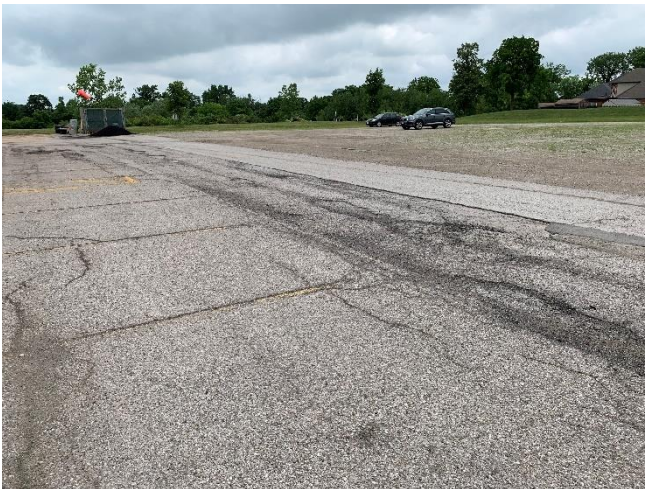
Deteriorated asphalt pavement on the northeast portion of the Site.

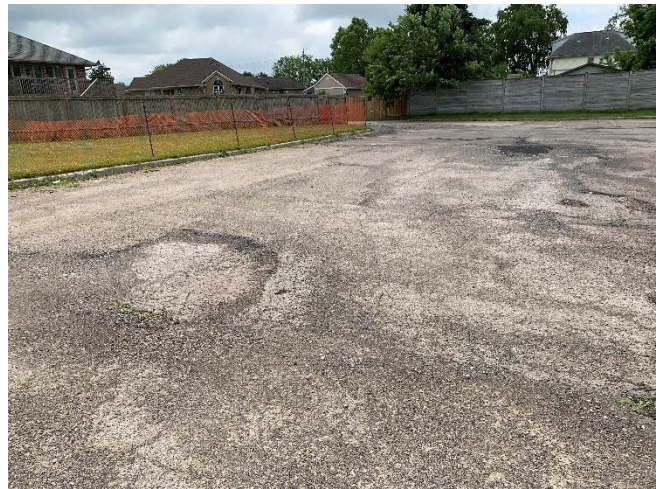
Deteriorated asphalt pavement on the east parking lot of the Site.

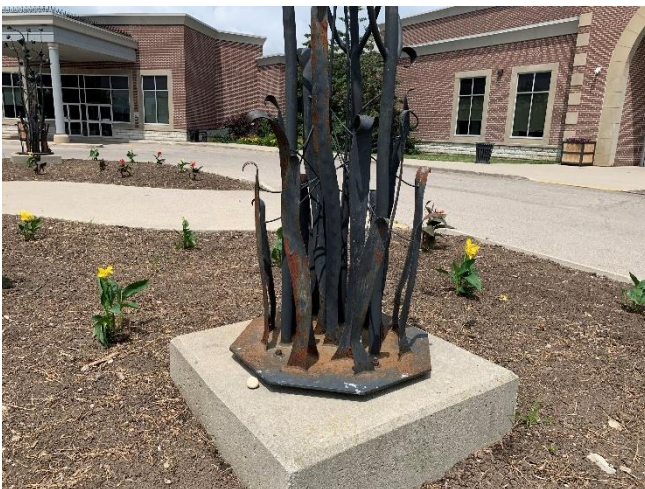
Decorative sculpture on the central portion.

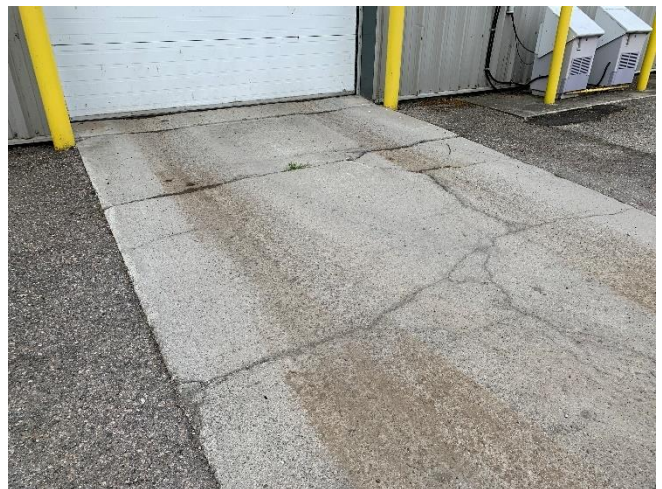
Deteriorated concrete pad adjacent to a drive-in door.

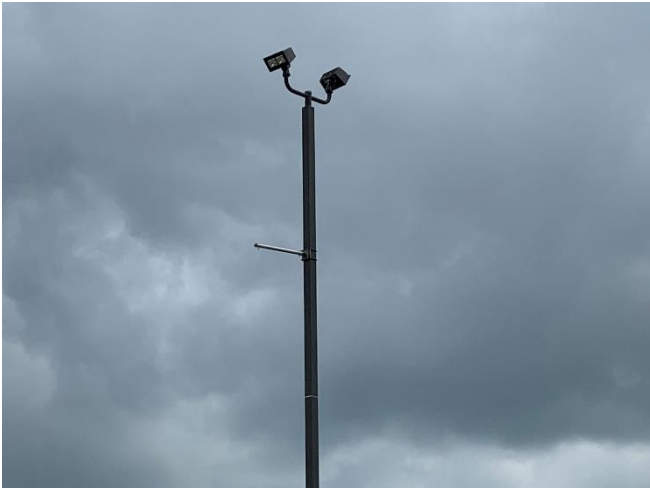
Typical Site lighting feature.

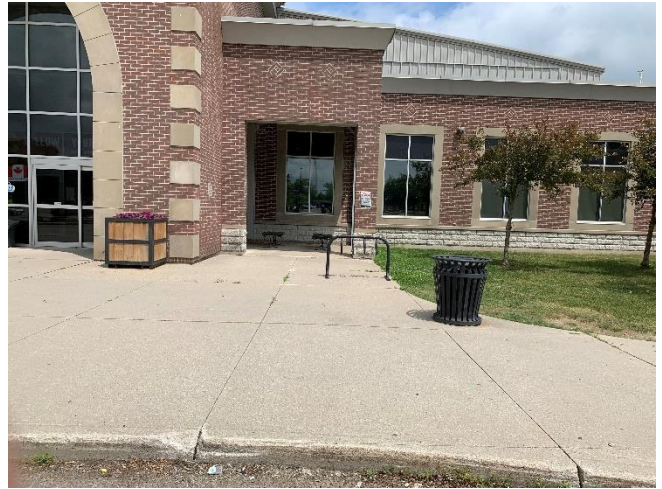
Pedestrian paving was noted in fair condition.
