# Property Condition Assessment & Facility Condition Index Analysis

**Aylmer Police Office  
20 Beech Street East,  
Aylmer, Ontario**

Prepared for:  
Town of Aylmer  
46 Talbot Street West,  
Aylmer, Ontario  
N5H 1J7

November 17, 2022  
IRC LB22-066CR-25445

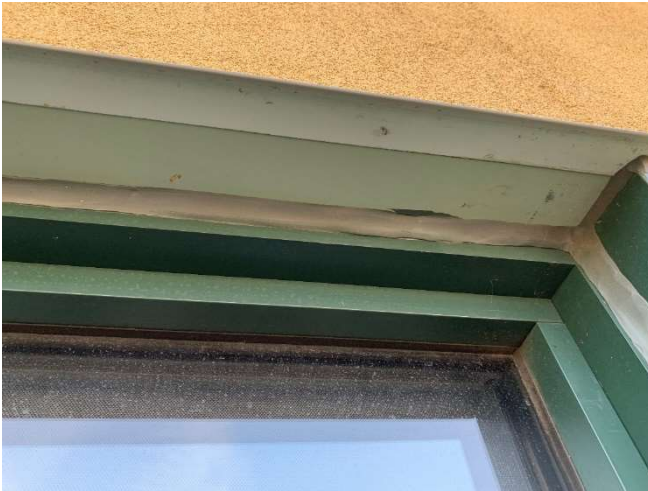
Close-up view of the perimeter sealant observed at a window head located along the west elevation.

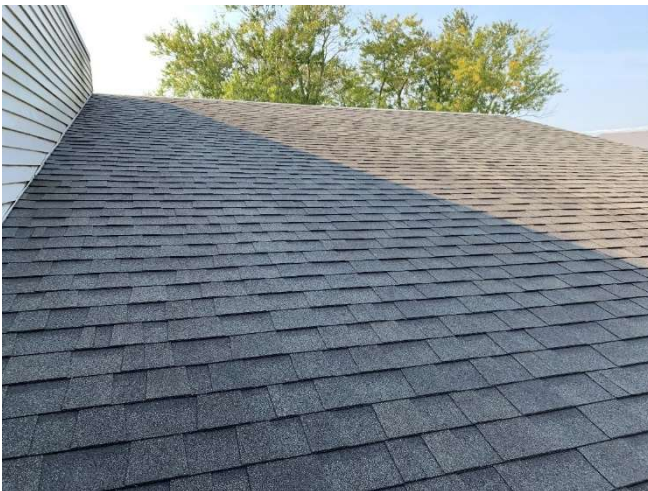
View of the asphalt shingle roofing observed at the south-west corner of the building.

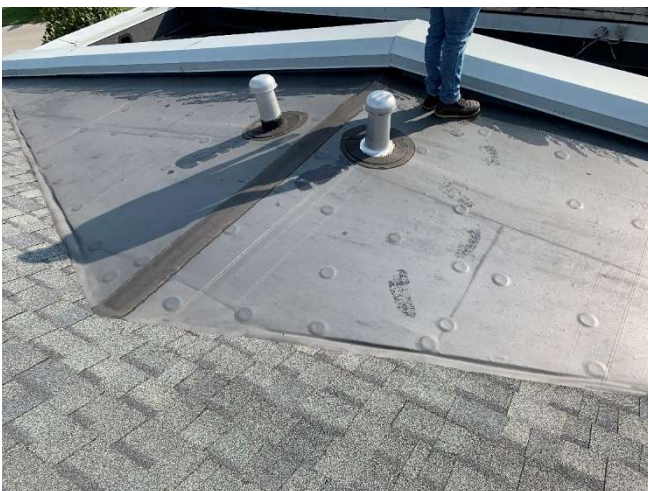
View of the single-ply EPDM membrane system observed on the low slope portions of the roof.

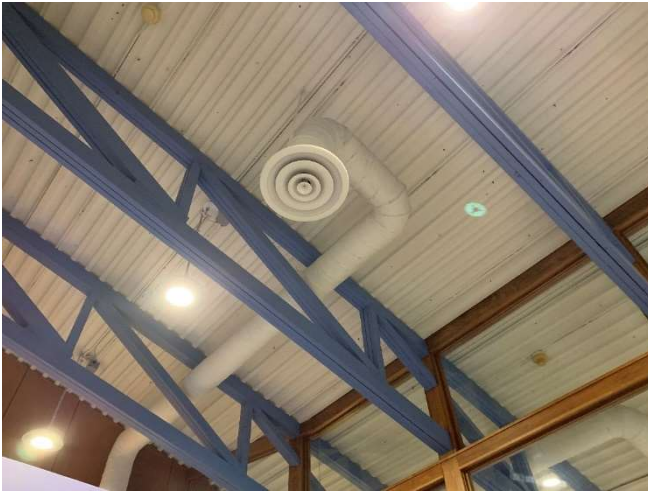
Exposed HVAC ductwork observed in the meeting room.

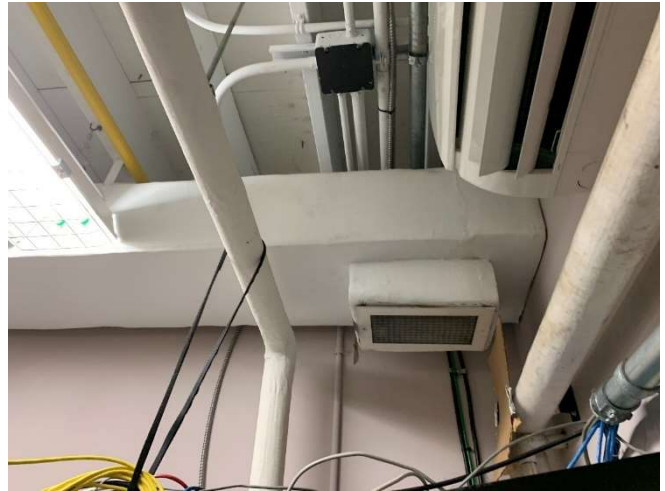
The HVAC ductwork was observed to be insulated.

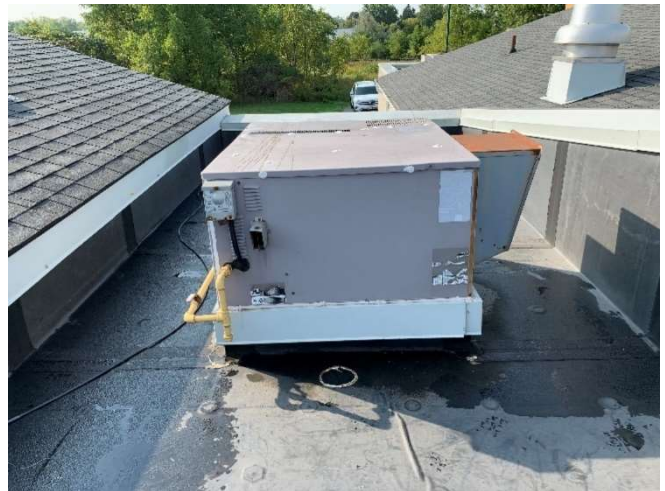
View of the package HVAC system located on the low sloped roofing at the north end of the building.

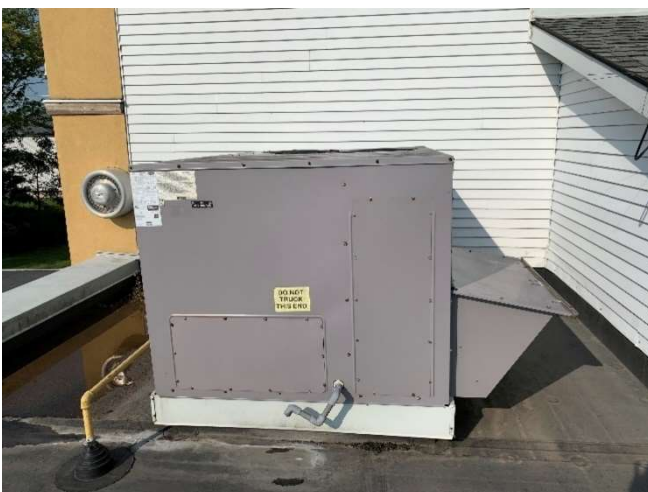
View of the package HVAC system located on the low sloped roofing at the south end of the building.

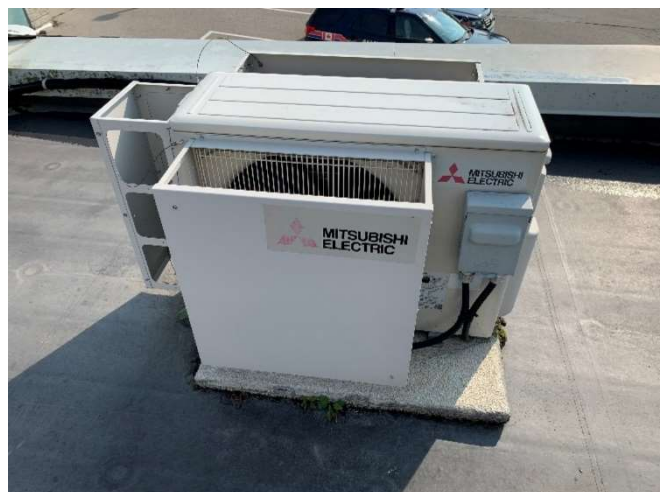
View of the split-system heat pump located on the low sloped roofing above the server room.

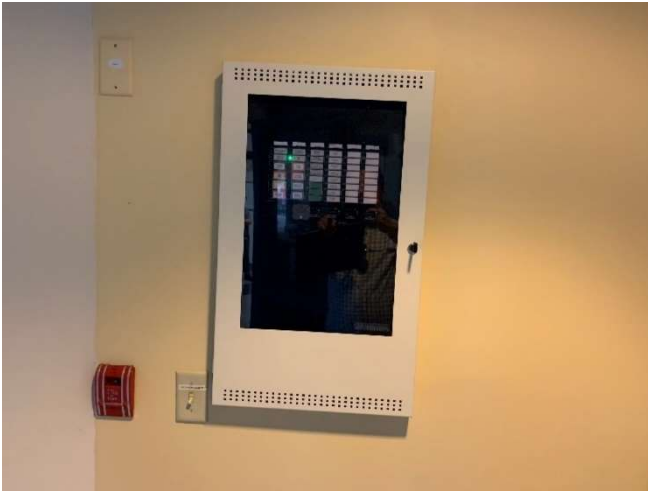
View of the fire alarm panel manufactured by Mircom.

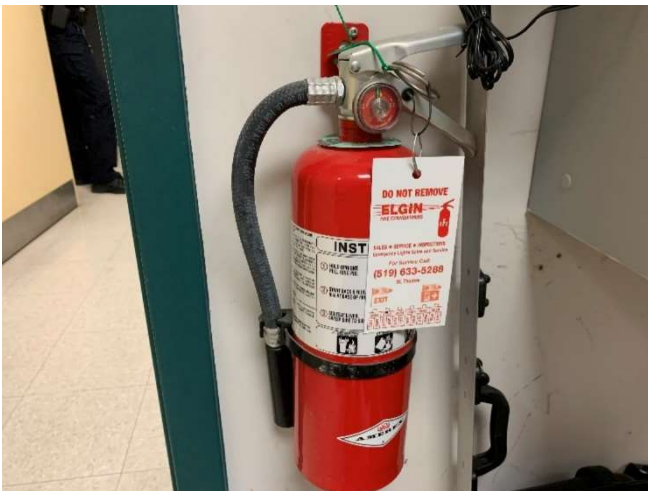
Fire extinguishers were observed at multiple locations.

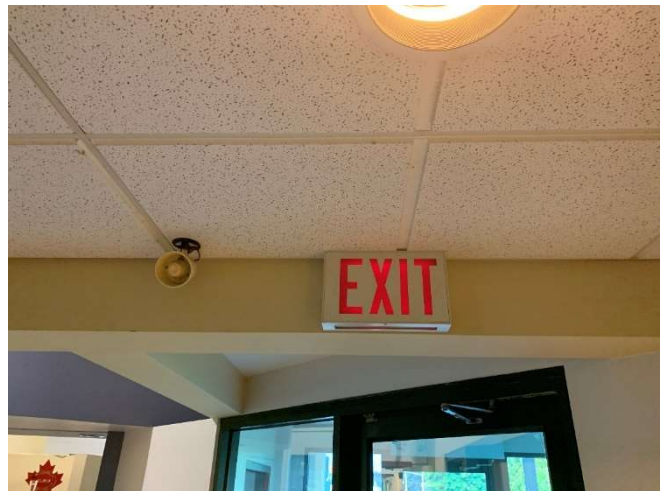
Exit signs were observed at exit doors.

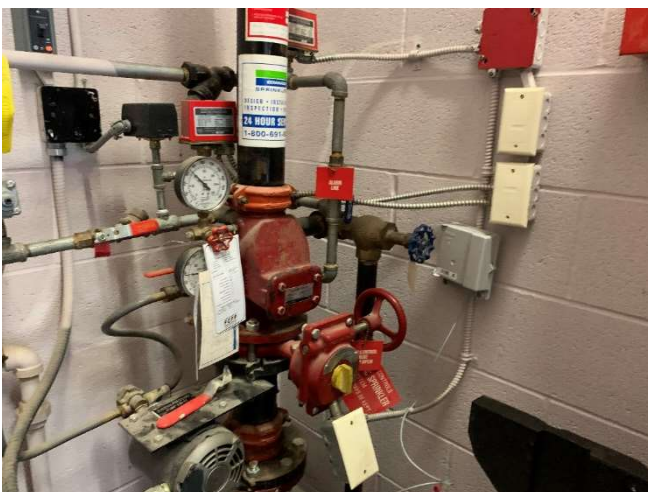
View of the sprinkler standpipe and valve system.

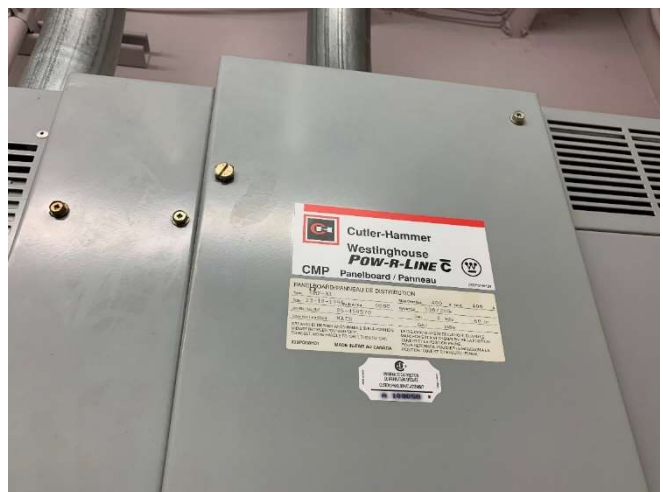
Close-up view of the main breaker panel manufactured by Cutler-Hammer.

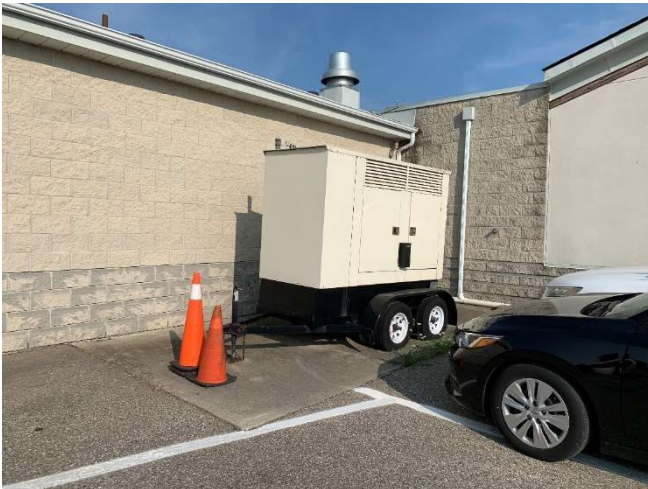
View of the emergency generator.

- IRC has carried an allowance for the replacement of the emergency generator within the next 10 to 20 years.

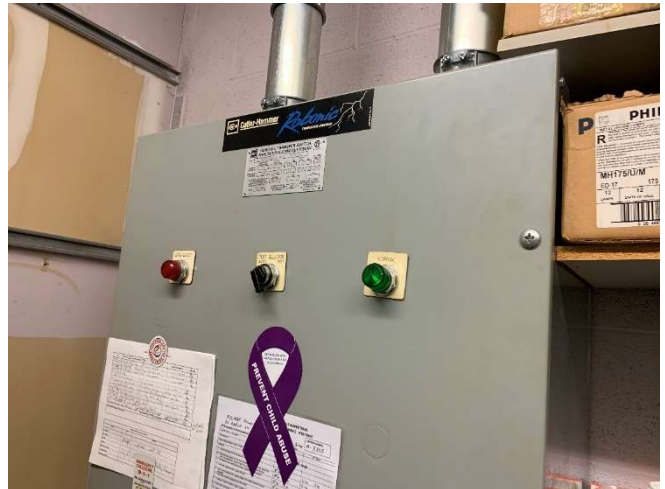
View of the automatic transfer switch located in the electrical room.

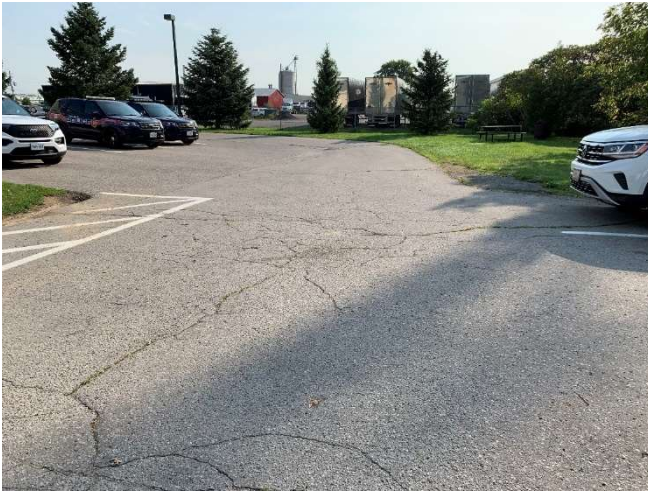
View of the asphalt roadway along the south end of the site.

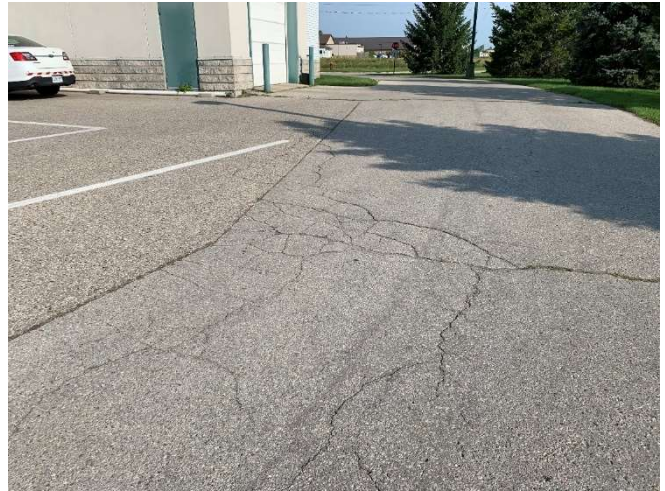
View of the asphalt roadway along the east end of the site.

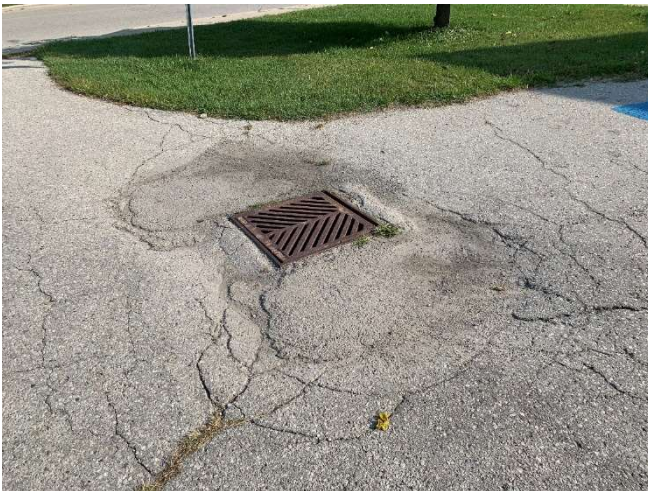
Settlement surrounding the catch basins was typical.

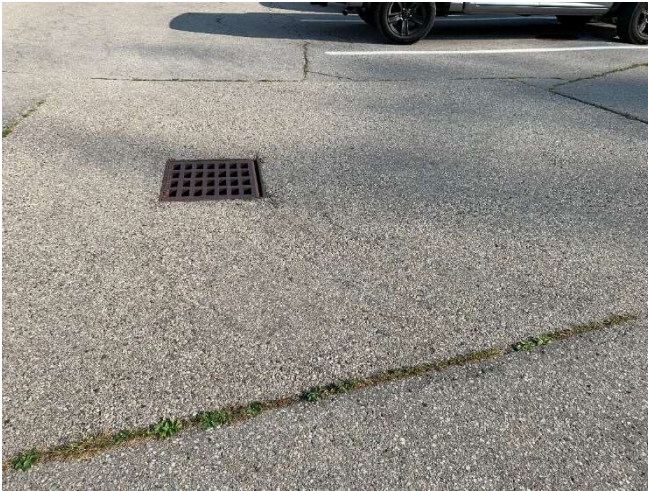
Upgraded catch basin cover observed.

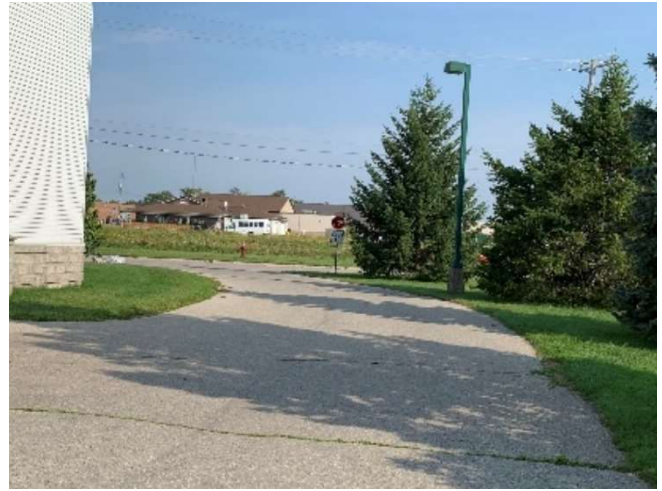
View of a typical light standard observed on the northeast portion of the site.

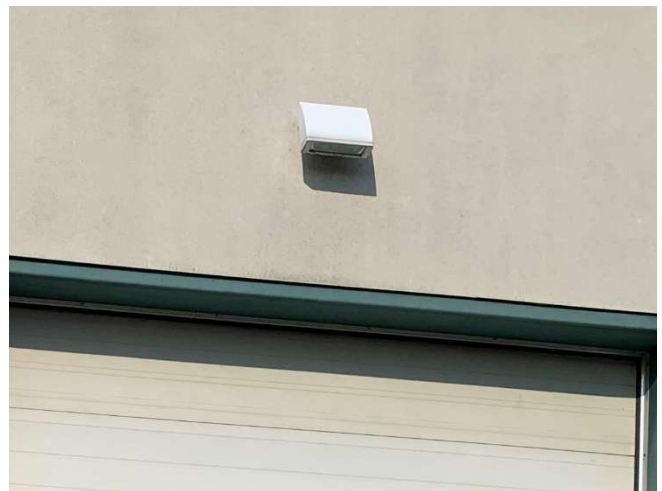
Exterior wall mounted light fixture observed.
